Post-Harvest Riparian Assessments on Small Streams: A Cumulative Examination (2016-2019)

Project Summary and Preliminary Findings

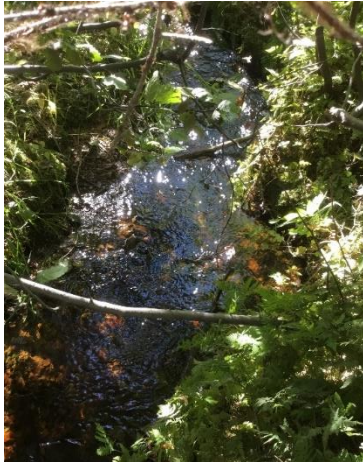
Small stream surveyed in Unit G,
Cutblock G-8. Uschenko 2018.
